# A study on the Charpy impact response of the cracked aluminum plates repaired with FML composite patches

*Faramarz Ashenai Ghasemi\*, Lotfali Mozafari Vanani\* and Ali Pourkamali Anaraki\**

## Abstract

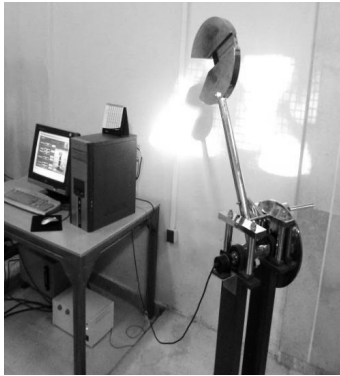
a) The Charpy test device

Figure 5: The Charpy test device and the specimen set up for testing

Charpy is a dynamic three point bending experiment of a beam. The experimental setup consists of the specimen, the fixture where the specimen is freely supported, and a pendulum with a defined mass attached to a rotating arm. The pendulum falls following a circular trajectory and hits to the test specimen at the middle span length and transfers its kinetic energy to it [17]. In this research a Charpy test device (Figure 5 (a)) was used for impact testing of all specimens according to ASTM E 23 – 02a [13]. The pendulum hammer had a mass of 15.200 kg and a disc radius of 150mm. The swing arm length and mass were 520mm and 5.270 kg respectively, leading to a speed at impact point of around 5.033 m/s and a stored energy of 218.5 J. The friction energy losses were about 1.9 J and the energy losses due to air resistance was neglected. The span distance in the test setup was 45mm. The final energy absorption of
